Oxid Met
DOI 10.1007/s11085-017-9774-9

ORIGINAL PAPER

HVOF and Laser-Cladded Fe–Cr–B Coating in Simulated Biomass Combustion: Microstructure and Fireside Corrosion

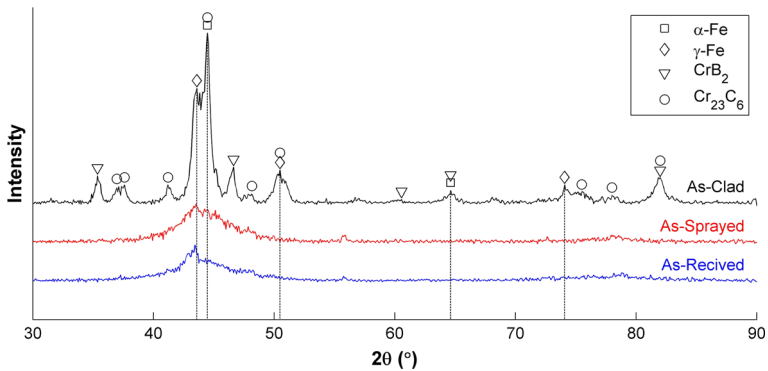
Figure 1 shows the phases that were present in the feedstock powder, the as-sprayed, and the as-clad material. The powder was predominantly amorphous with a broad hump, a typical feature of metallic glasses, seen centred around 44° [12].

Fig. 1 XRD of Weartech® SHS™ 7574 powder as-received, after coating with HVOF onto a 304 stainless steel substrate and after laser cladding onto a 304 stainless steel substrate

Whilst there were no clearly defined peaks, the broad amorphous hump is centred on a γ -Fe reflection suggesting that some fraction of the powder had a crystalline structure.

The XRD of the HVOF-sprayed coating showed a slightly broader hump, with a less well-defined peak, corroborating the proposed beneficial effects of HVOF spray in retaining amorphous fraction in metallic glass feedstocks. The literature suggests that thermal spray can retain the amorphous fraction in the feedstock [7, 13–15]. It is suggested that this effect is due to the rapid cooling rates that occur when the molten particles from the spray process are incident on the substrate, on the order of 10^6 K s^{-1} [8]. Although after HVOF spray the coating became more amorphous, the characteristic peak of α -Fe became visible. This appearance of ferrite is consistent with the process of melting and resolidification of the austenite phase observed in the as-received powder.

The laser-cladding process removed some of the amorphous fraction observed in the as-received powder. The two most prominent peaks in the XRD were still those of the γ -Fe and α -Fe phases. There was also obvious formation of CrB_2 and Cr_{23}C_6 . Whilst the peaks were more defined, the patterns were much more diffuse than would be expected from a fully crystalline structure, suggesting some amorphous fraction had been retained.

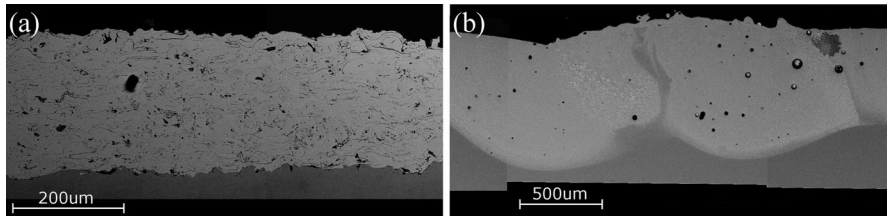
As-deposited coating cross sections can be seen in Fig. 2. The mean coating thickness before exposure was measured to be $235 \pm 4 \mu\text{m}$ for the HVOF-sprayed coating and $732 \pm 20 \mu\text{m}$ for the laser cladding. The HVOF coating was well bonded to the substrate, and there were no interfacial cracks present at the interface. Occasional porosities were noticed at the splat boundaries as well as within the splat. The laser cladding was metallurgically bonded to the substrate, and there were some gas pores present. Some mixing of the substrate is observed between tracks. Figure 3 shows the cross section of the coatings after exposure both without any

Fig. 2 BSE images showing the cross-sectional microstructure of the **a** HVOF-sprayed coating and **b** laser cladding

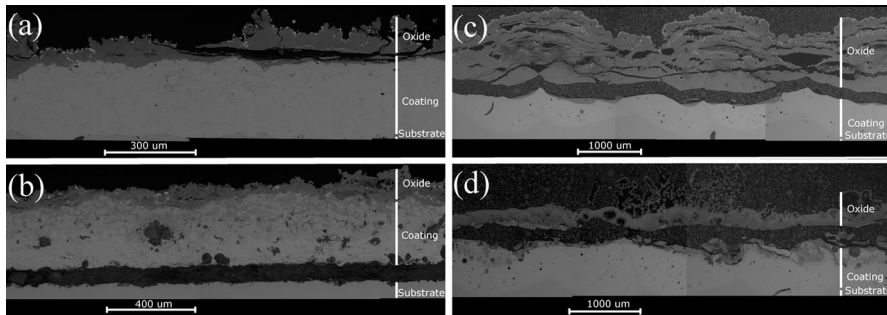
Fig. 3 BSE images showing the cross-sectional microstructure of the **a** HVOF-sprayed coating with no deposit, **b** HVOF-sprayed coating with KCl deposit, **c** laser cladding with no deposit and **d** laser cladding with KCl deposit

deposit and with the KCl deposit at 700 °C for 250 h. The average thickness of the HVOF-sprayed coating without any deposit was $274 \pm 3 \mu\text{m}$, and with KCl deposit was $276 \pm 7 \mu\text{m}$. This minimal change in thickness has been observed in similar Fe–Cr–B coatings under similar conditions [16]. The laser cladding was strongly affected by the exposure, with an average coating thickness of $381 \pm 24 \mu\text{m}$ for no deposit and $557 \pm 33 \mu\text{m}$ for the KCl deposit. The HVOF-sprayed coating after exposure with KCl delaminated from the substrate.

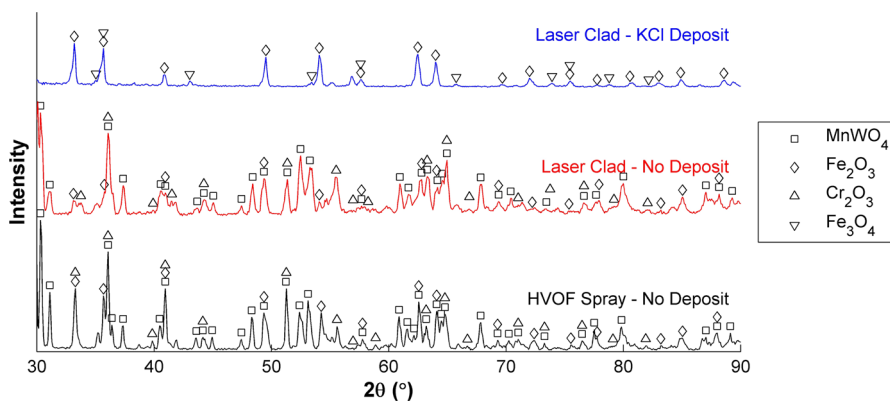
XRD analysis of the exposed coatings is shown in Fig. 4. The integrity of the HVOF-sprayed coating with KCl deposit was poor, and it was not possible to use XRD on that sample. Both the HVOF-sprayed and laser-clad samples showed strong reflections from MnWO_4 , when no deposit was present. This oxide was not detected on the surface of the laser cladding with a KCl deposit. MnWO_4 reacts with gaseous Cl_2 to form MnCl_2 and WO_2Cl_2 [17]. No chlorides were detected on the surface of the samples without any deposit, suggesting that HCl from the gas did not react to form chlorides, and instead the KCl deposit was providing the gaseous Cl_2 needed for the removal of MnWO_4 . Cr_2O_3 is another phase that was observed in both the HVOF-sprayed and laser-clad samples without any deposit, but not when KCl was present. The phase most dominant across all of the samples, however, was Fe_2O_3 . On the laser-clad sample with the KCl deposit, the only other major phase identified other than Fe_2O_3 was Fe_3O_4 . It is well established that Fe_2O_3 and Fe_3O_4 are much less protective than Cr_2O_3 . This suggests when KCl was involved the clad material, with 25 wt% Cr, failed to form a protective chromia layer.

Fig. 4 XRD of HVOF and laser-clad samples after exposure

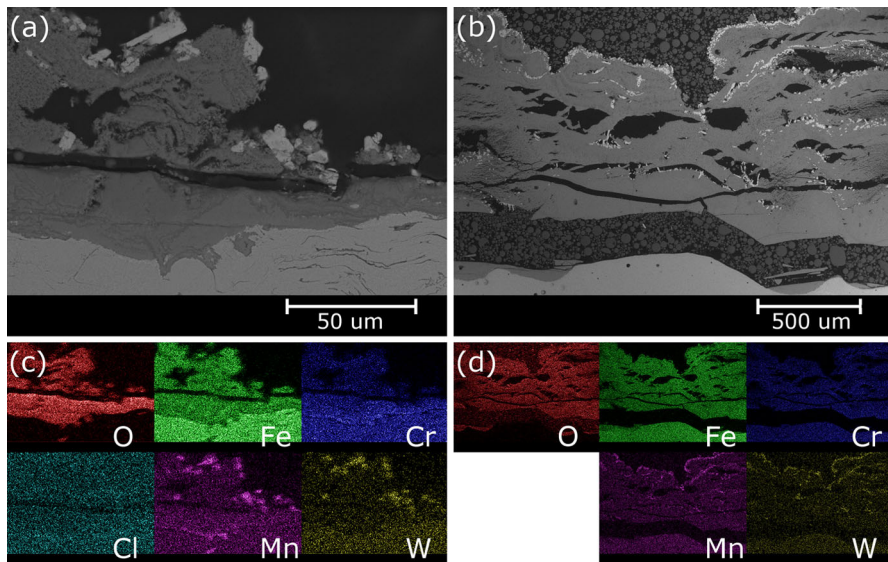
Figure 5 shows the cross-sectional images of both the samples without any deposit and corresponding EDX maps. Figure 5a shows a thick dark contrast oxide layer with a bright oxide phase on top. The external oxide layer was mainly composed of Fe and O with a small amount of Cr. This is likely to be a combination of Fe_2O_3 and Fe_3O_4 as determined by XRD. The Cr_2O_3 , which was also detected in XRD, is underneath the Fe-rich oxide. MnWO_4 was located on the top surface of the Fe-rich oxide. Cl was not detected in EDX maps in the cross section, suggesting that HCl did not react with the coating to form any chlorides.

The laser-clad sample is shown in Fig. 5b. The scale thickness was significantly more than that of the HVOF-sprayed sample. It showed many of the same phases as those found in the HVOF-sprayed sample. The oxide layer was mainly composed of Fe, Cr and O, with the Cr present in higher quantities towards the scale-coating

Fig. 5 Cross-sectional BSE images of the HVOF-sprayed (a) and laser-clad (b) samples after 250 h at 700 °C with no deposit. The corresponding EDX maps are shown in c for HVOF coating and d for laser cladding

interface. EDX analysis of these regions showed the oxides were likely of the same composition as those found in the HVOF-sprayed sample. MnWO_4 was also present in the scale of the laser-clad sample, as was confirmed with EDX mapping and XRD.

Unlike the samples with no deposits seen in Fig. 5, these KCl-covered samples did not show the MnWO_4 phase. A Cr-rich oxide formed underneath the MnCl_2 . This Cr-rich layer did not contain any Fe, although no Cr_2O_3 was detected in the XRD due to the thickness of the mixed corrosion products. The laser-clad sample after 250-h exposure is shown in Fig. 6b where the mixed corrosion product layer was observed to be over 300 μm thick. The outer oxide was a Fe-rich oxide which was porous at the top. The Cr was only detected below the Fe oxide, an area which

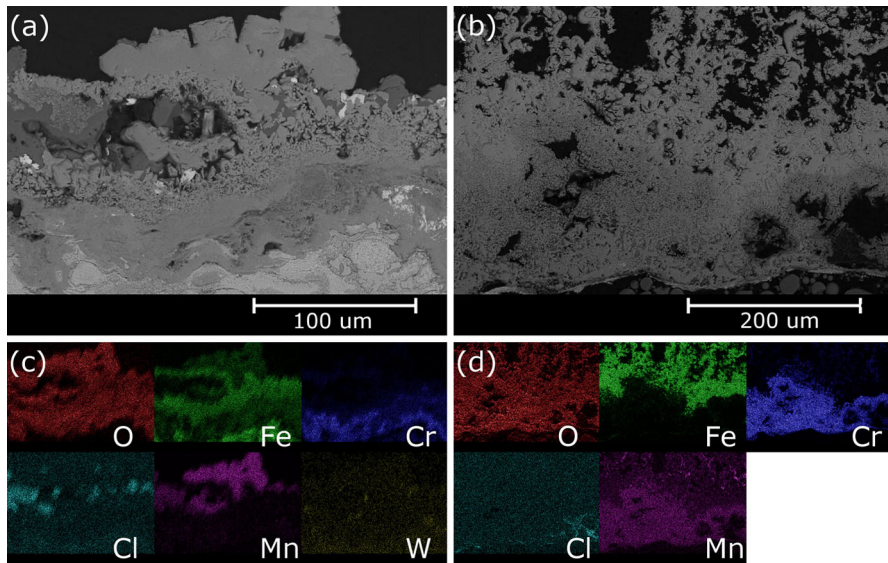
The cross-sectional images of the samples with deposits are shown in Fig. 6. When comparing these cross sections to those with the KCl deposit, the most noticeable difference was the presence of Cl in the scales. Mn and O were detected on the outside of the scale with a Fe-rich oxide formed underneath. EDX maps showed another Mn-rich layer contained Cl embedded within this Fe-rich oxide. EDX spot analysis suggested its composition is close to MnCl_2 . One mechanism for the formation of MnCl_2 is through MnO_2 interacting with HCl via Eq. (1) [18]. This formation process is corroborated by the presence of Mn and O which is seen in Fig. 6a as the cubic, fan-like structure at the surface of the sample.

Fig. 6 Cross-sectional BSE images of the HVOF-sprayed (a) and laser-clad (b) samples after 250 h at 700 °C with KCl deposit. The corresponding EDX maps are shown in c for HVOF coating and d for laser cladding

also contains Mn. This was a mixture of Cr and Mn oxides although there was no Cr or Mn phase detected in the XRD due to the small penetration depth. Cl was detected underneath the oxide scales, suggesting that the scales were not protective in nature. Cl ions can migrate through the non-protective oxide readily.

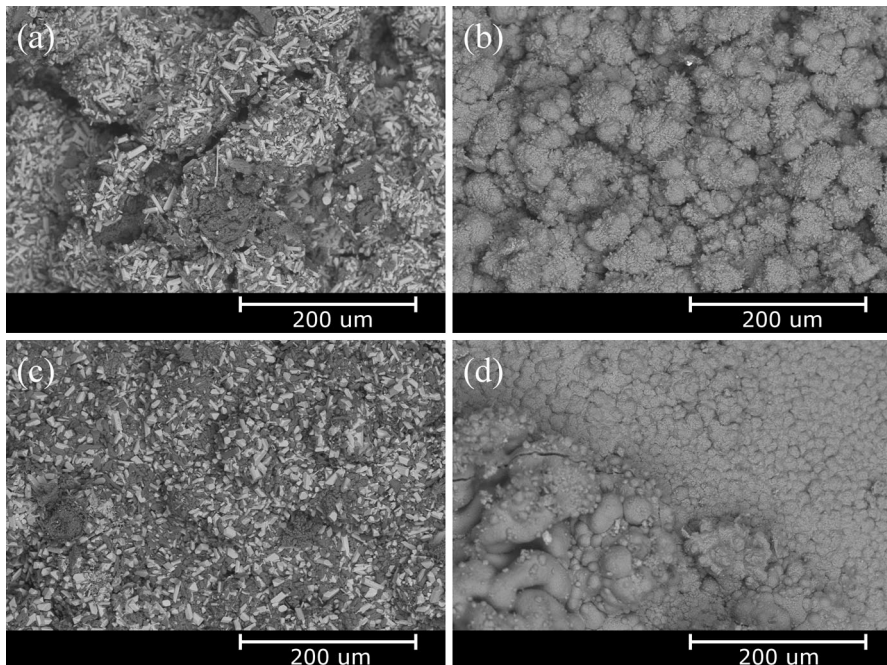
Figure 7a, c showed the morphology of the oxide scales grown on the HVOF-sprayed coating and laser cladding without any deposit. In both cases, the bright phase in the BSE image was detected to be MnWO_4 . The oxides were rod shaped and grew up to 20 μm in length on the HVOF-sprayed coating.

The top surface of the HVOF-sprayed coating with KCl deposit, Fig. 7b, showed two morphologically different phases. There was an iron oxide phase making up the bulk of the surface similar to all of the other samples; however, this sample was unique in that it had a second, diamond-shaped, iron oxide.

Similarly, there were two distinct textures that could be seen on the surface of the laser-clad sample with a KCl deposit, Fig. 7d. Small globular-shaped oxides formed the majority of the sample surface, which comprised of Fe and O. EDX and XRD analysis showed it to be Fe_2O_3 . EDX analysis did not detect any Cr, suggesting this was a very thick region of Fe_2O_3 . The other region seen on the bottom of Fig. 7d showed this is a mix of Fe_2O_3 and Cr_2O_3 .

Fig. 7 Top surface after 250 h in 500 ppm HCl, 5% O₂, N₂ Bal. at 700 °C **a** HVOF spray with no deposit, **b** HVOF spray with KCl deposit, **c** laser cladding with no deposit, **d** laser cladding with HCl deposit
